PERFORMANCE OF WOOD PLASTIC COMPOSITE FOUNDATION ELEMENTS IN
POST-FRAME AND LIGHT-FRAME SHEAR WALLS

A thesis submitted in partial fulfillment of
the requirements for the degree of

MASTER OF SCIENCE IN CIVIL ENGINEERING

WASHINGTON STATE UNIVERSITY
Department of Civil and Environmental Engineering

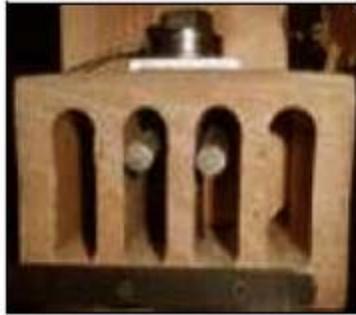
Figure 3.1 Duchateau's (2005) WPC sill plate section with steel dowels running through the cavities of the sill plate and into studs which are pocketed in the sill plate.

Duchateau (2005) proposed a continuously embedded sill plate after testing a variety of WPC sill plates. The most successful was a stranded section shown in Figure 3.1, with pockets to facilitate connection of the studs to the sill plate. Steel dowels were inserted through the end stud and cavity of the WPC sill plate to create a holdown. The primary failure modes were in flexure of the sill plate and tension perpendicular to the extrusion. Duchateau commented that these failures might be prevented if the WPC sill plate were continuously embedded into the concrete to remove flexure and to reduce the tension forces by sharing them with intermediate

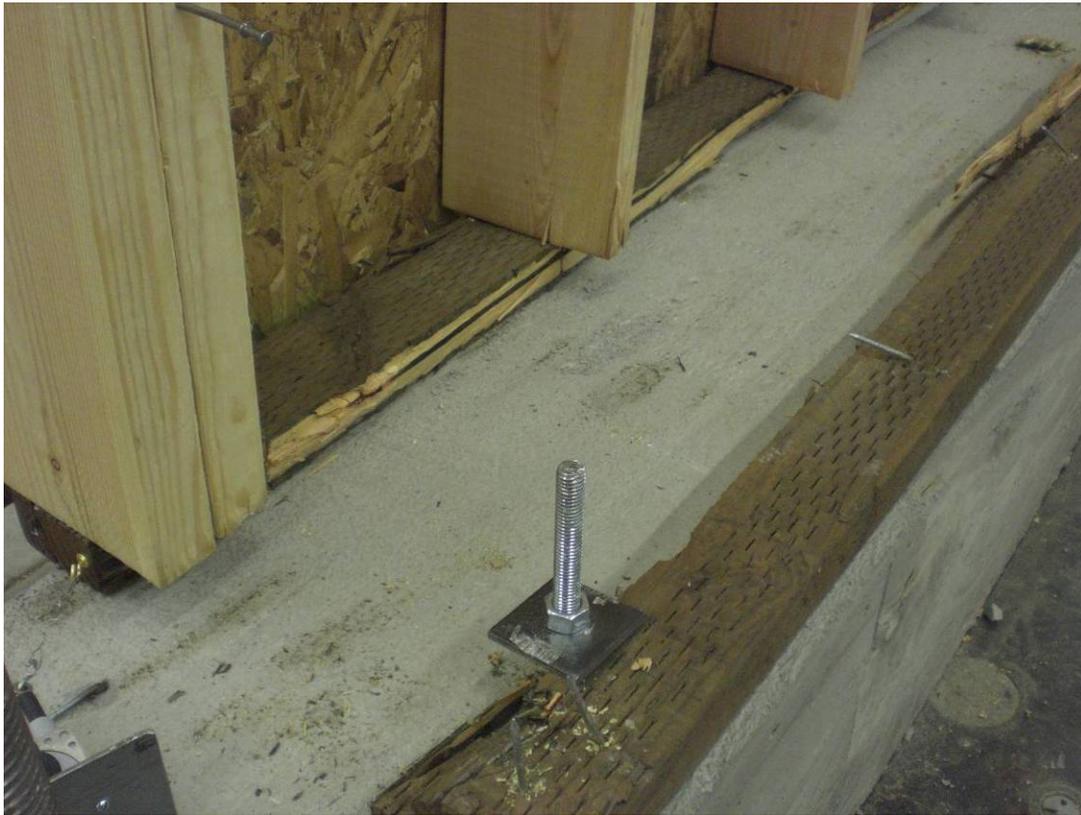
Figure 3.4 Splitting of PPT Hem-fir sill plate without holdowns

The control walls with a PPT sill plate and no holdowns failed in a similar manner described by Mahaney (2002). The sill plate split due to cross-grain bending along the line of the anchor bolts. The split was sudden and brittle, and once split, the wall could not resist load and would translate back and forth with the actuator. Figure 3.4 shows a typical split of the sill plate. The nails that attached the sheathing to the sill plate at the corners also underwent withdrawal from the sheathing as shown in Figure 3.5. Little damage was visually apparent outside of the two corners.

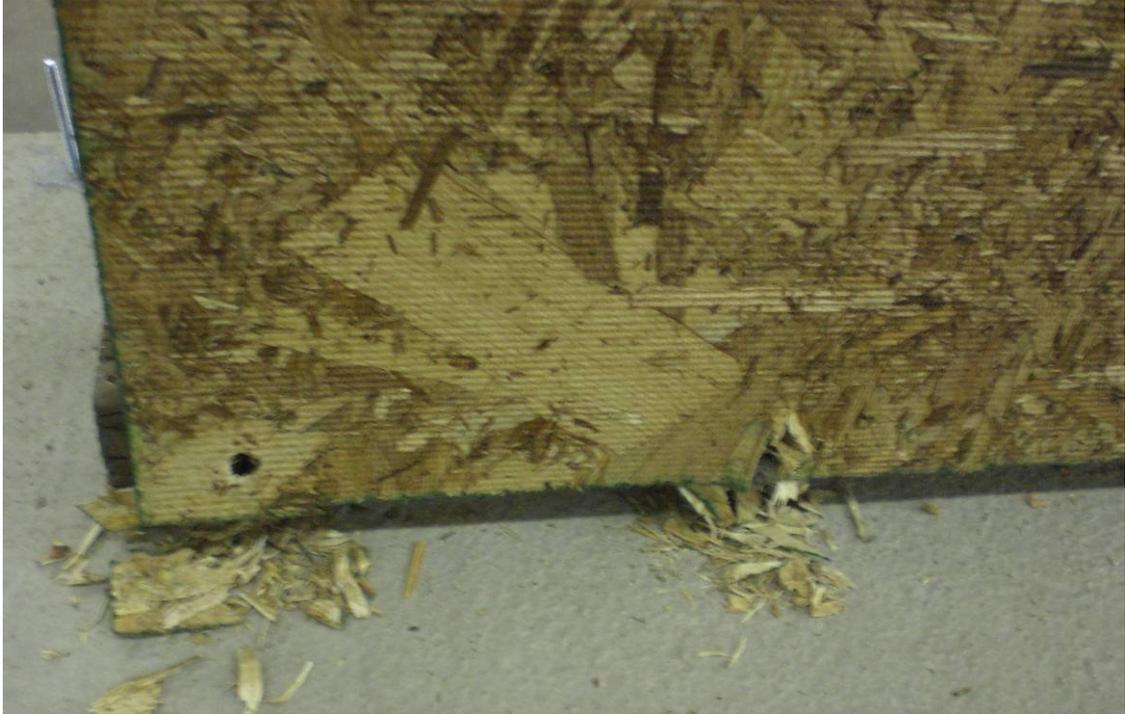
Figure 3.5 Nail head pull-through from sheathing of walls without holdowns

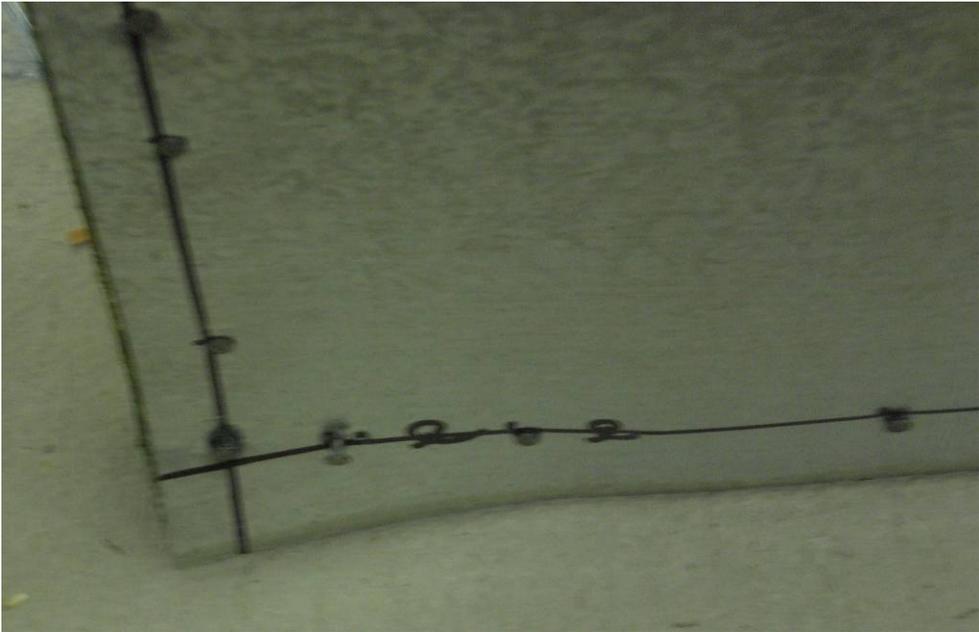
Figure 3.6 Nail withdrawal of triangular gusset plate at corner of wall

The monotonic test of the wall with a triangular gusset plate failed with the nails withdrawing from the WPC sill plate as shown in Figure 3.6. No damage was observable on the gusset plates, which suggests that an even lighter gage sheet metal might be adequate. The gusset plate also prevented the two primary failure mechanisms of the sheathing nails in the control wall. It prevented the nails from pulling through or tearing out the OSB. Significant bending was seen in the sill plate and separation of the melt bonds was seen during testing as shown in Figures 3.7 and 3.8 respectively.

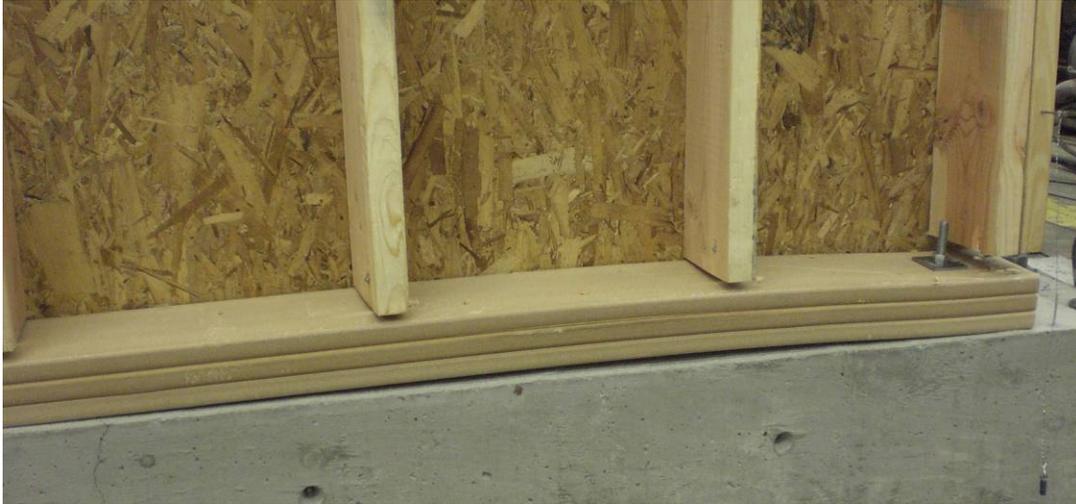
Figure 3.7 Bending of thickened WPC sill plate with triangular gusset plates (attached to other side)

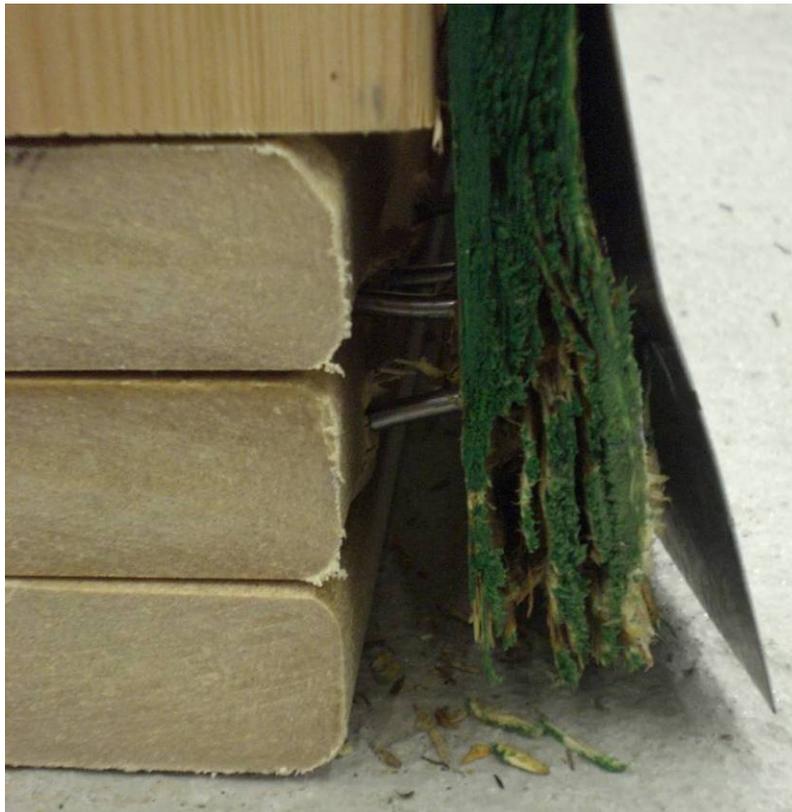
Figure 3.8 Separation of the sill plate along the melt bond

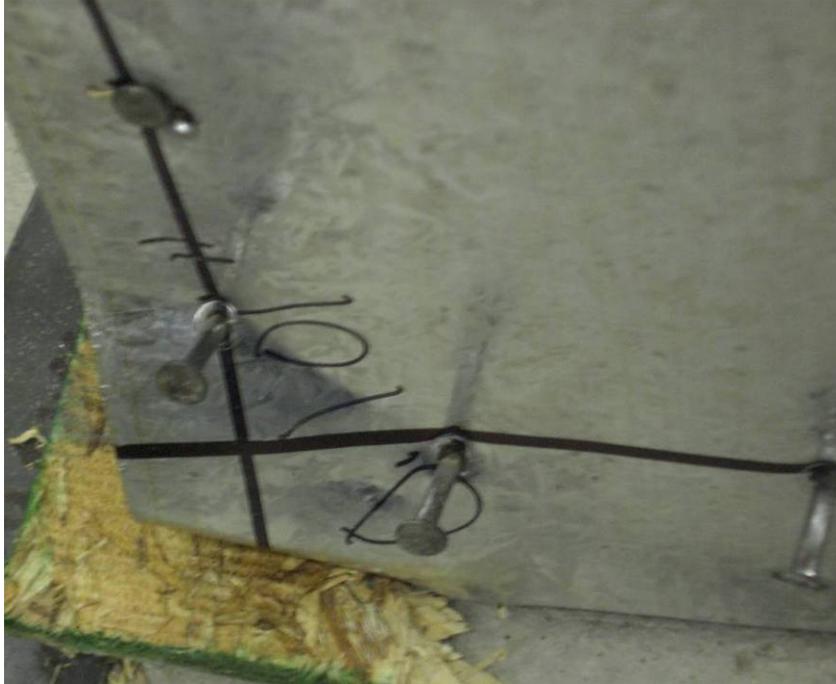
Figure 3.9 Buckling of metal gusset plate and damage of OSB at corner of wall

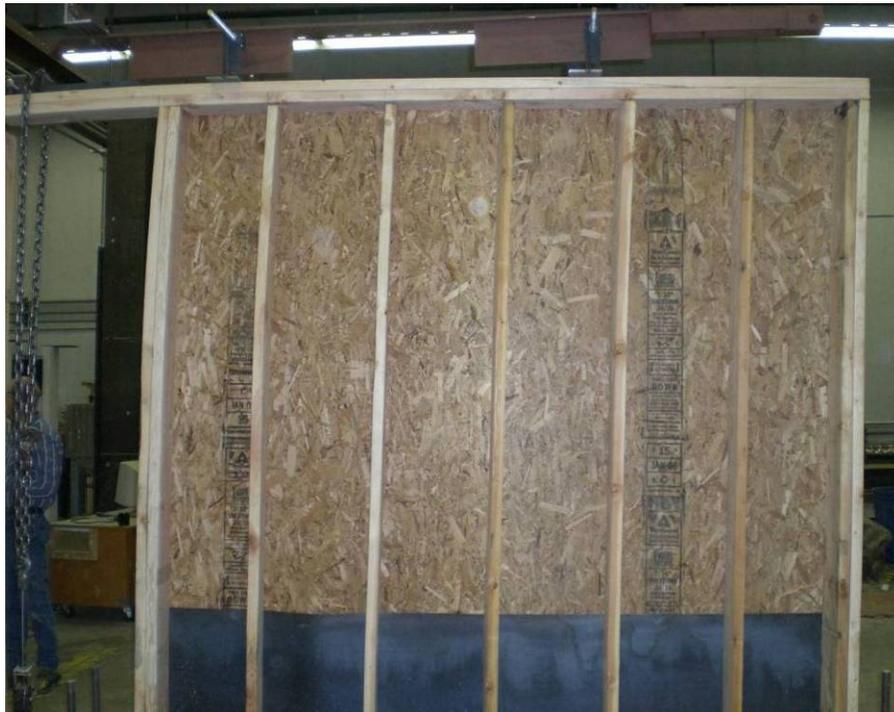
Figure 3.10 Restraint of uplift forces on the monotonic wall with a continuously embedded sill plate

The monotonic test for the wall with continuously embedded WPC sill plate showed the potential of such a system. During testing it was noted that the double top plate was bending and causing the actuator to push upwards on the wall. To help prevent this effect, a restraining chain was wrapped over the top plate at the connection to the actuator. Unfortunately, this prevented uplift from occurring on the wall as shown in Figure 3.10. However, it also prevented the major failure of the cyclic tests: delamination of the melt bond. Since a true commercial product would not be melt bonded, but simply extruded into the correct shape, the plane of weakness might not govern. The monotonic results suggest the capability of such a system, which is nearly twice the strength of the other walls tested as summarized in Tables 3.1 and 3.2.

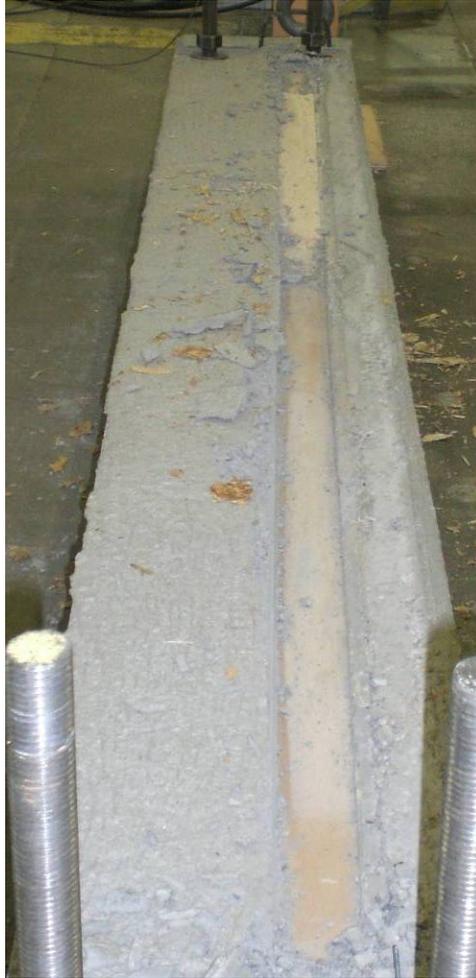
Figure 3.11 Failure of the first continuously embedded wall. Light colored area is WPC failure and the dark colored area is melt bond failure.

The cyclic tests with the embedded WPC sill plate failed primarily at the melt bond. Since the quality of the melt bond was variable, the performance of these walls was variable as well. The first cyclic wall was considerably stronger, and the reason was easily seen when viewing the foundation after failure. The WPC failed at a combination of the melt bond and extruded WPC as shown in Figure 3.11. It was estimated that 80% of the failure was material failure and 20% was melt bond failure. The second cyclic wall was the weakest and the melt bond failure was estimated at nearly 80%. The third wall was in between the other two with an estimated 60% failure due to the melt bond.
